iSeries Server 270, 800, 810, 820, 825, 830, 840, 870,
890, SB2, and SB3 Hardware Problem Analysis and
Isolation

Version 5 Release 2

SY44-5914-01

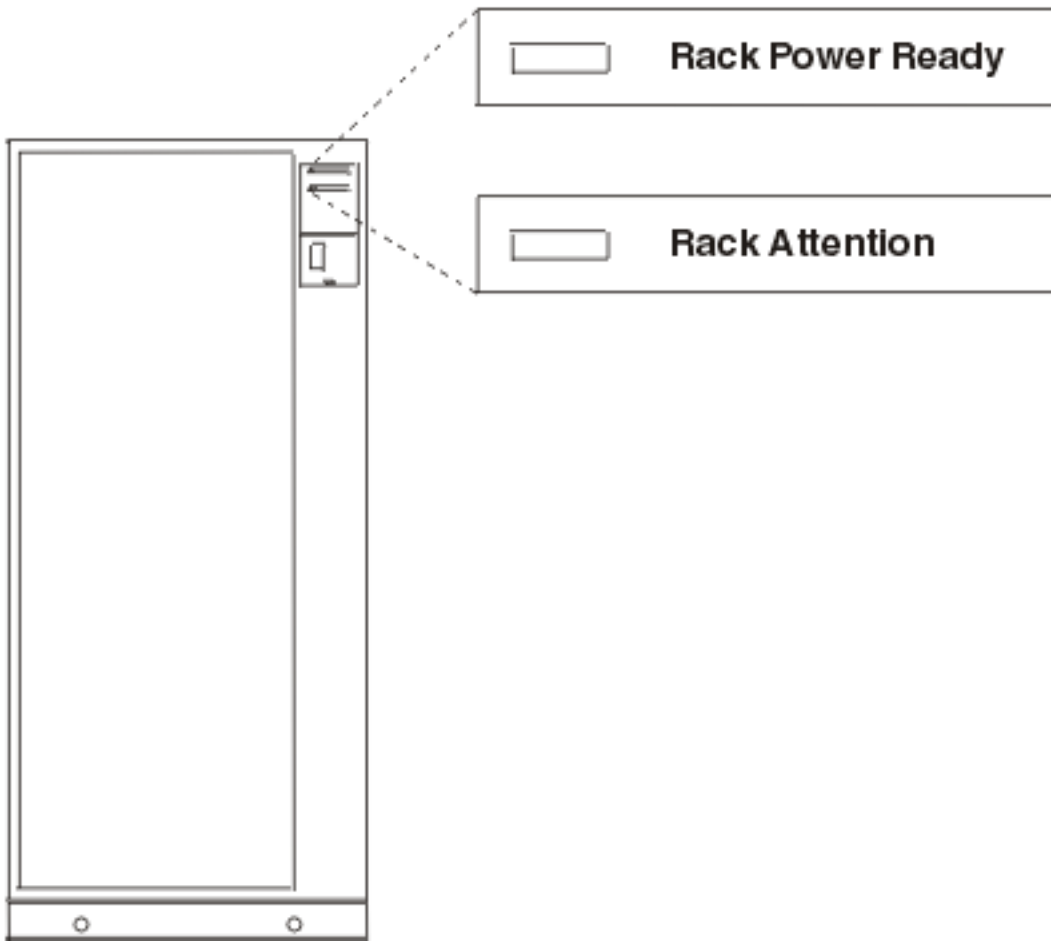
Figure 1. Stage 2 frame (FC 9309) rack attention light

Note: Stage 2 frames (FC 9309) have a rack attention light on the frame control panel.

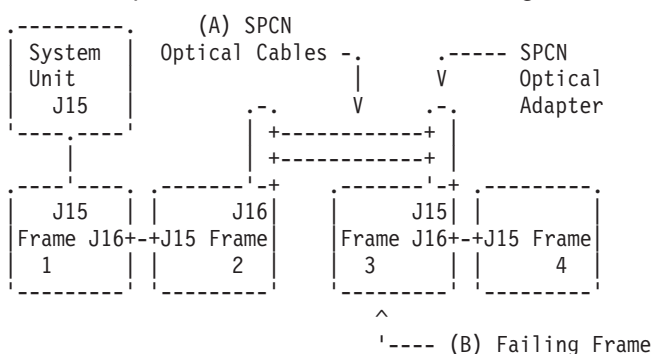
17. Does the Attention light continue to blink for more than 1 minute?
 - **Yes:** Continue with the next step.
 - **No: This ends the procedure.**
18. Do SPCN optical cables **A** connect the failing frame **B** to the preceding frame in the string?

- **No:** Go to step **20 (See page 52)**.
- **Yes:** Remove the SPCN optical adapter **A** from the preceding frame in the string that cannot become powered on.

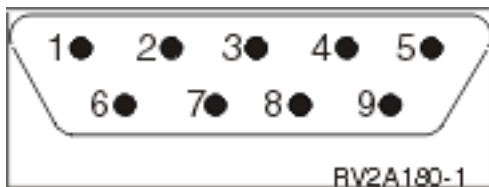
20. Perform the following:
- Power off the system.
 - Disconnect the SPCN frame-to-frame cable from J15 on the PCC of the first secondary frame that cannot become powered on.
 - Connect the negative lead of a multimeter to the system frame ground.
 - Connect the positive lead of the multimeter to pin 2 of the SPCN cable.
Note: Use an insulated probe or jumper when performing the voltage readings.
 - Note the voltage reading on pin 2.
 - Move the positive lead of the multimeter to pin 3 of the SPCN cable.
 - Note the voltage reading on pin 3.

Is the voltage on both pin 2 and pin 3 from 1.5 V dc to 5.5 V dc?

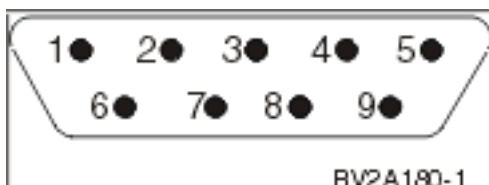
21. Perform the following:
- Follow the SPCN frame-to-frame cable back to the preceding frame in the string.
 - Disconnect the SPCN cable from J16 on the PCC, AC module, or SPCN card.
 - Connect the negative lead of a multimeter to the frame ground.
 - Connect the positive lead of a multimeter to pin 2 of J16.
Note: Use an insulated probe or jumper when performing the voltage readings.
 - Note the voltage reading on pin 2.
 - Move the positive lead of the multimeter to pin 3 of J16.
 - Note the voltage reading on pin 3.

Is the voltage on both pin 2 and pin 3 from 1.5 V dc to 5.5 V dc?

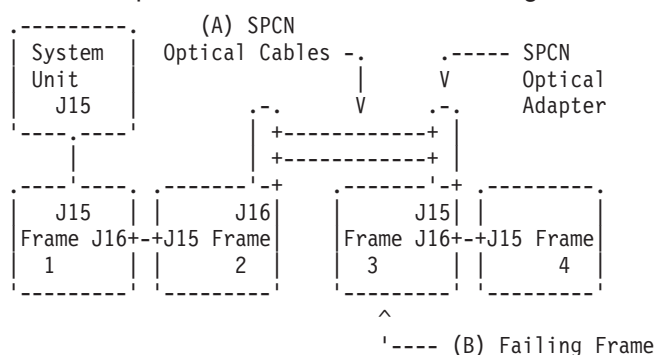
46. Do SPCN optical cables **A** connect the failing frame **B** to the preceding frame in the string?

- **No:** Go to step **48 (See page 58)**.
- **Yes:** Remove the SPCN optical adapter **A** from the preceding frame in the string that cannot become powered on. See Remove and replace procedures in the Repair and Parts information for the system.

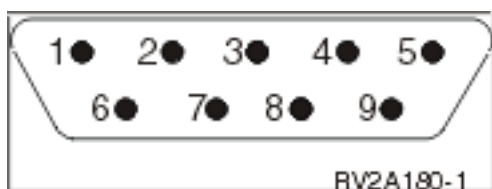
- Note the voltage reading on pin 2.
- Move the positive lead of the multimeter to pin 3 of the SPCN cable.
- Note the voltage reading on pin 3.

Is the voltage on both pin 2 and pin 3 from 1.5 V dc to 5.5 V dc?

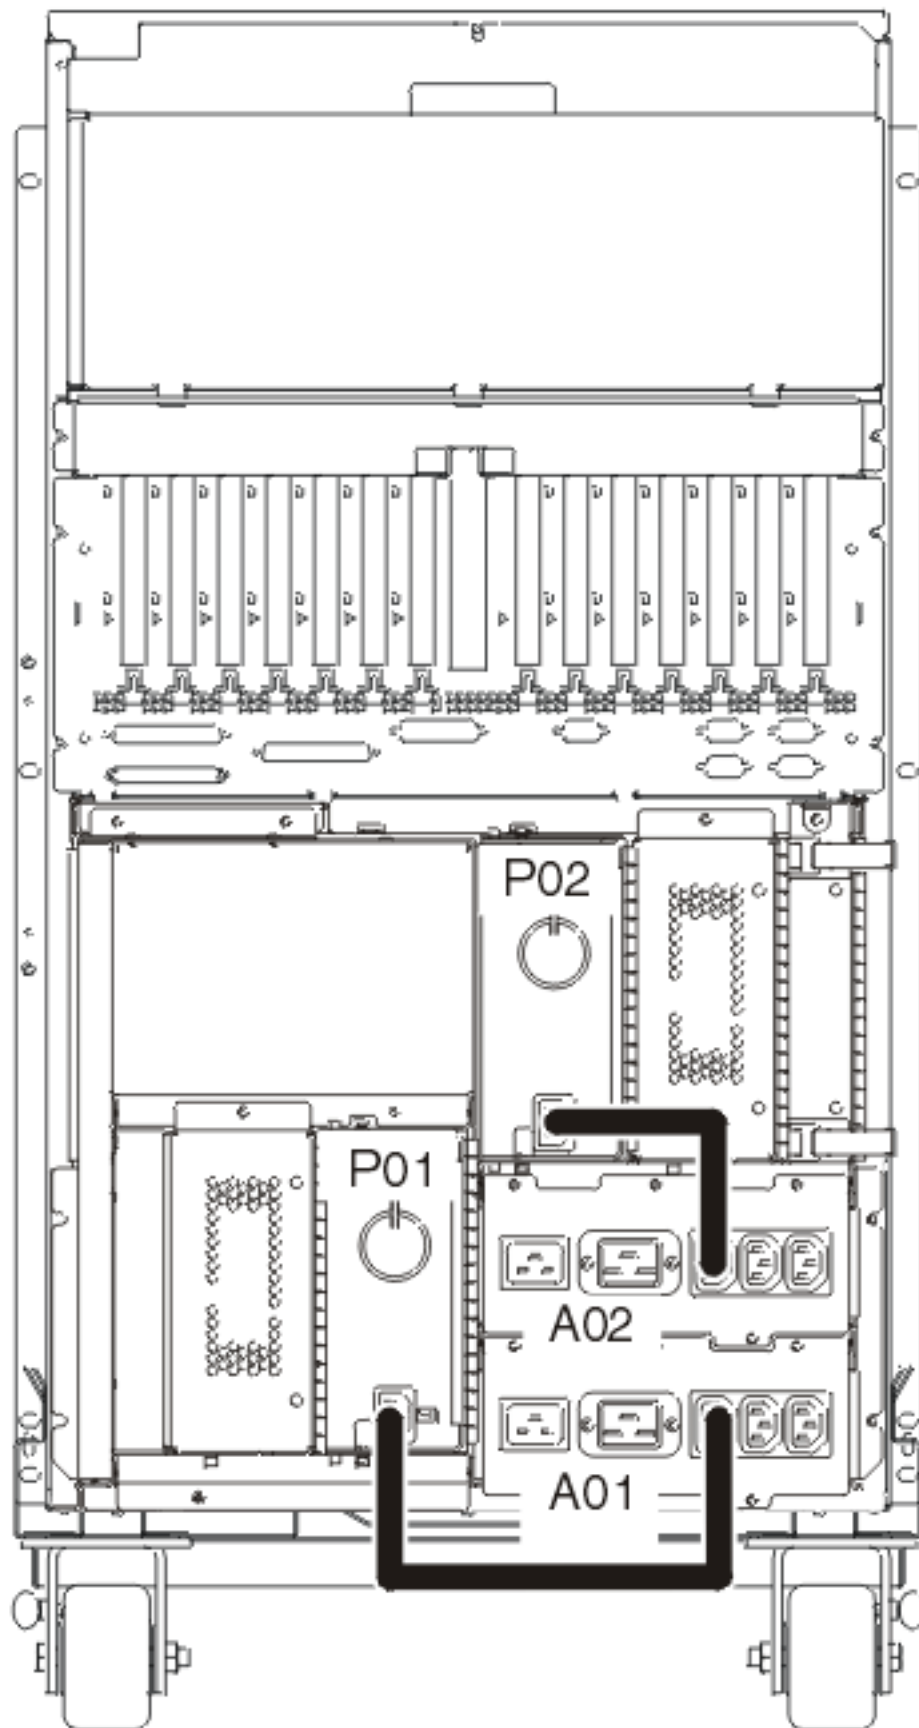
Figure 1. Dual line cord drawing for FC 5074, FC 5079, FC 5094, FC 5294, and FC 9094

- FC 5095, FC 0595 (SRC 1xxx 1510): See Locations - 5095, 0595 Expansion I/O Tower to determine the location of ac line cord 1.
 - FC 5095, FC 0595 (SRC 1xxx 1520): See Locations - 5095, 0595 Expansion I/O Tower to determine the location of ac line cord 2.

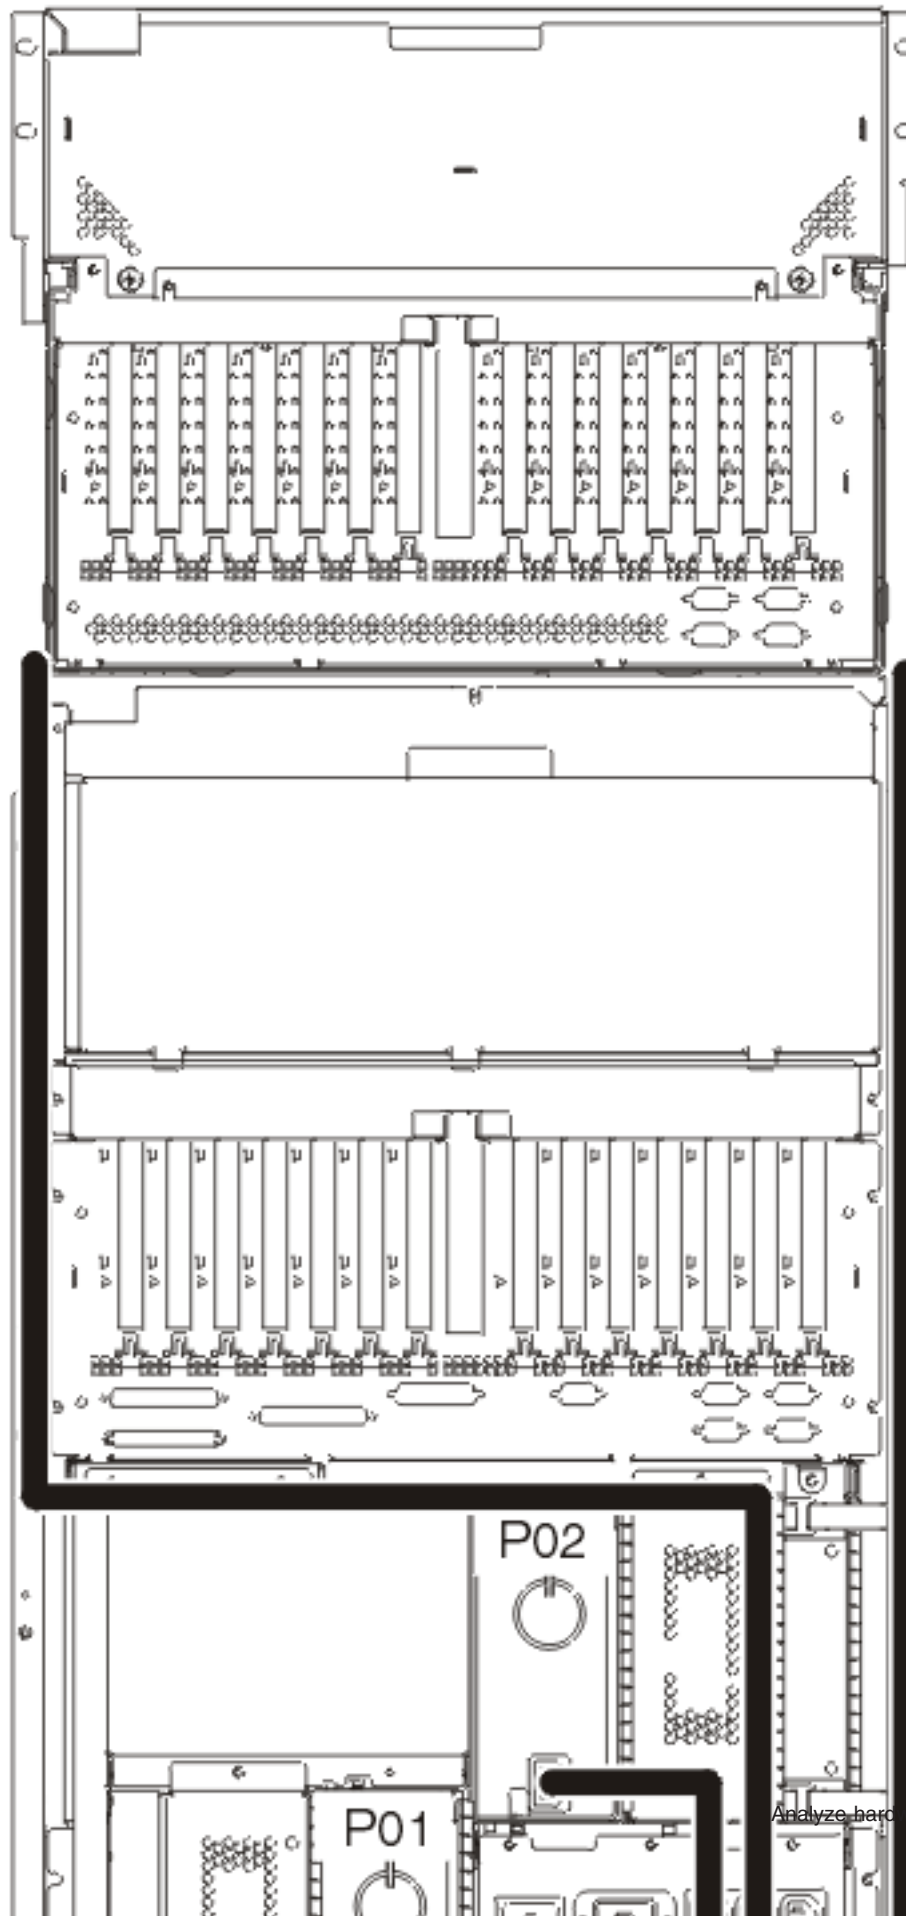
Figure 2. Dual line cord drawing for FC 5078, 0578, FC 5088, and FC 0588

- b. Trace mainline ac power cord 1 from the External Power Connector on a Model 820, or the ac jumper cord for the SRC you are working on.

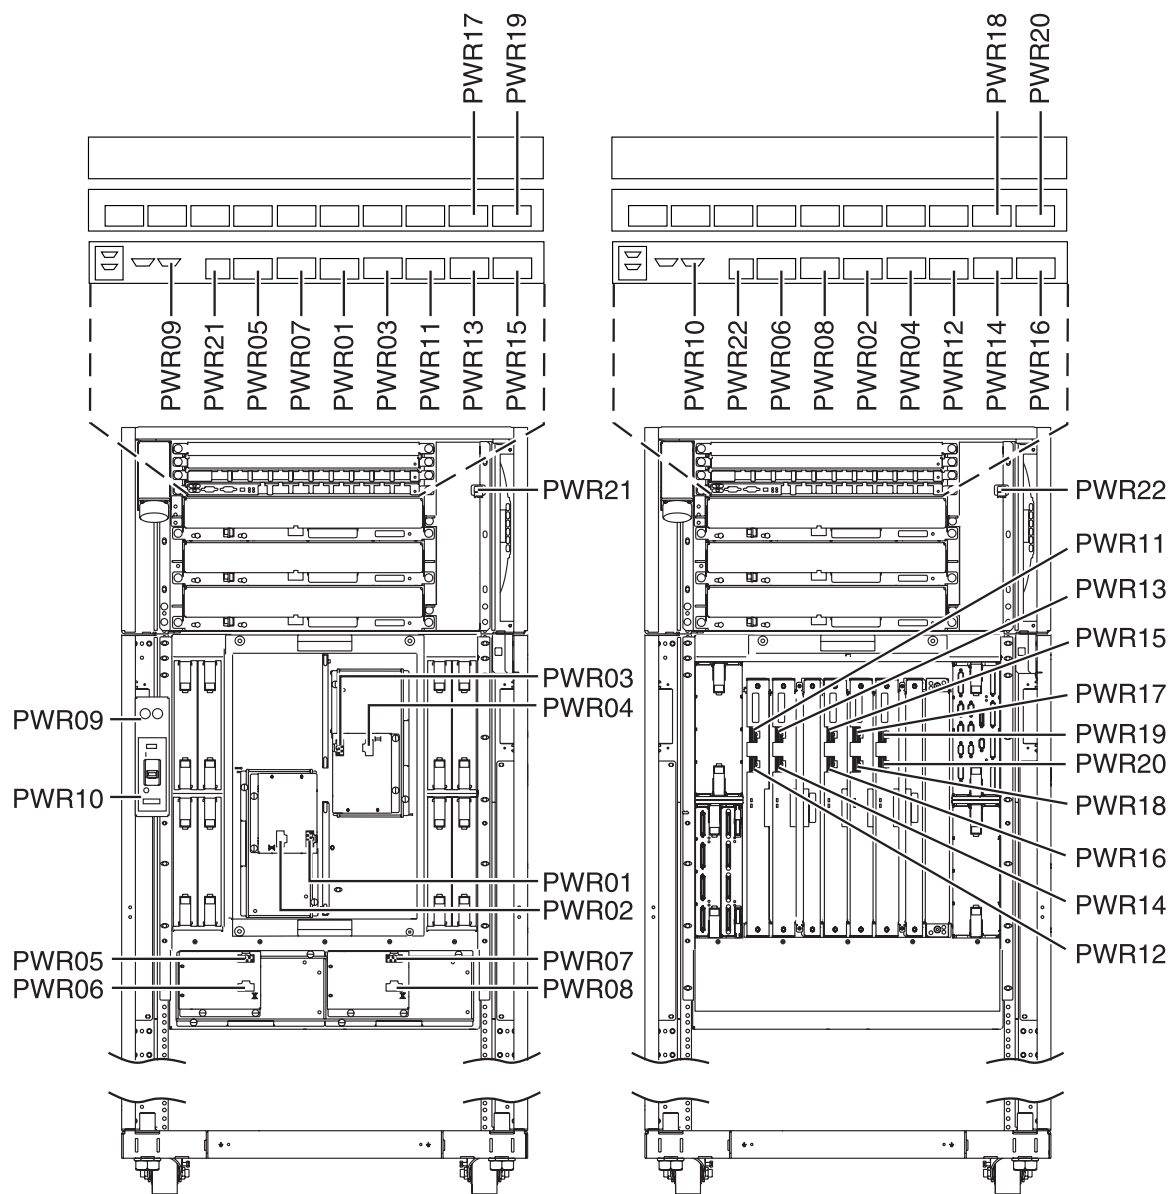
Figure 1. Part locations for power and signal cables

A power or signal cable is the failing item.

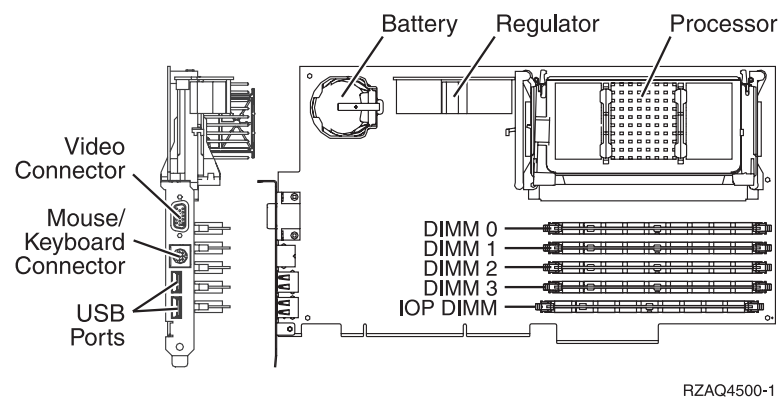
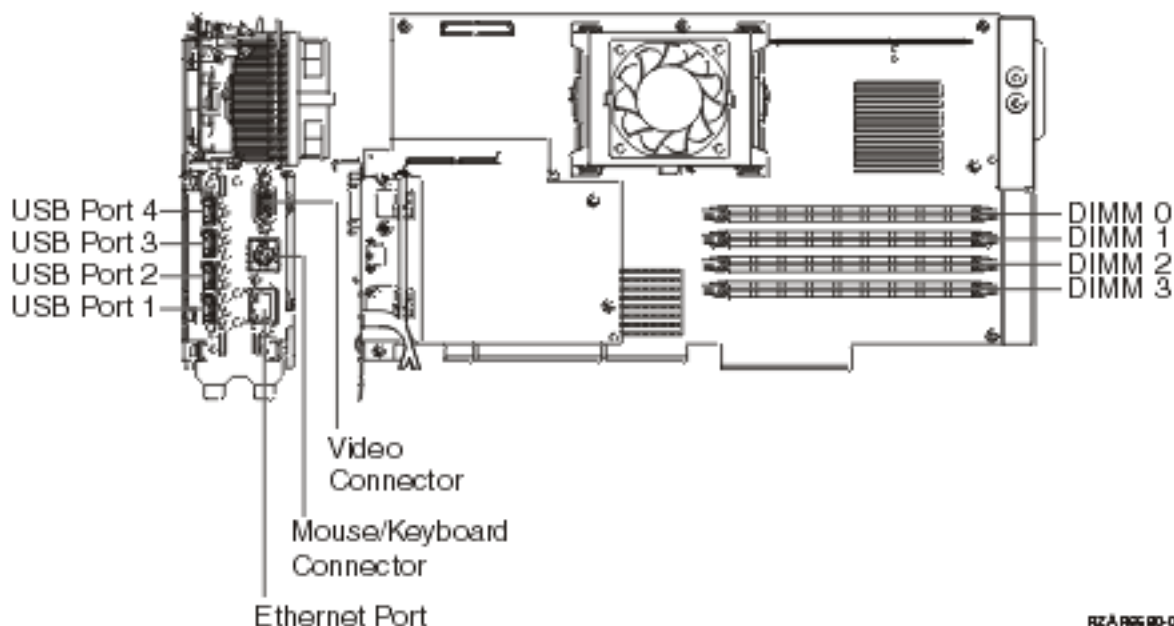
Figure 1. Locations of DIMM 0, DIMM 1, DIMM 2 and DIMM 3 on 2890 Integrated xSeries Server (IXS) card.

In both figures, the **first** DIMM from the top of the IXS card (DIMM 0) is the failing item. To determine the part number, go to symbolic FRU "MEMORY" on page 411.

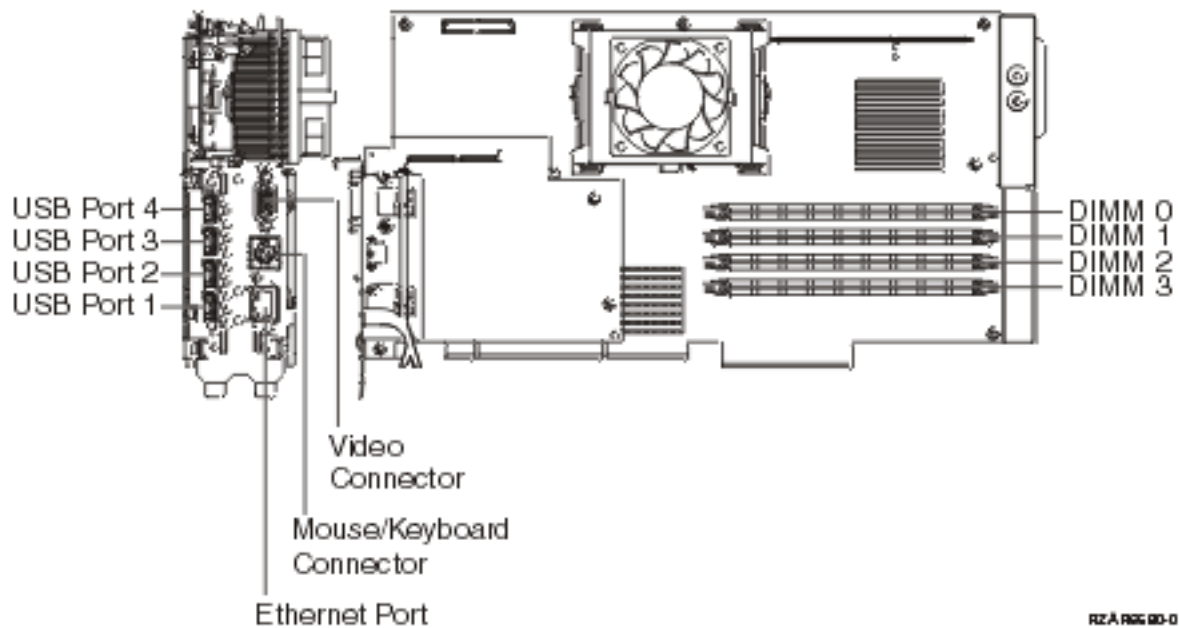
Figure 1. Locations of DIMM 0, DIMM 1, DIMM 2 and DIMM 3 on 2892 Integrated xSeries Server (IXS) card.

The **first** or **second** DIMM from the top (DIMM 0 or DIMM 1) of the IXS card is the failing item. To determine the part number, go to symbolic FRU “MEMORY” on page 411.

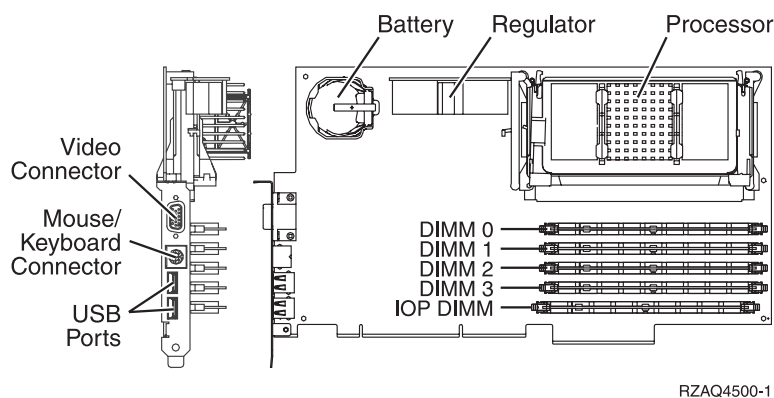
Figure 1. Locations of DIMM 0, DIMM 1, DIMM 2 and DIMM 3 on 2890 Integrated xSeries Server (IXS) card.

In both figures, the **second** DIMM from the top of the IXS card (DIMM 1) is the failing item. To determine the part number, go to symbolic FRU “MEMORY” on page 411.

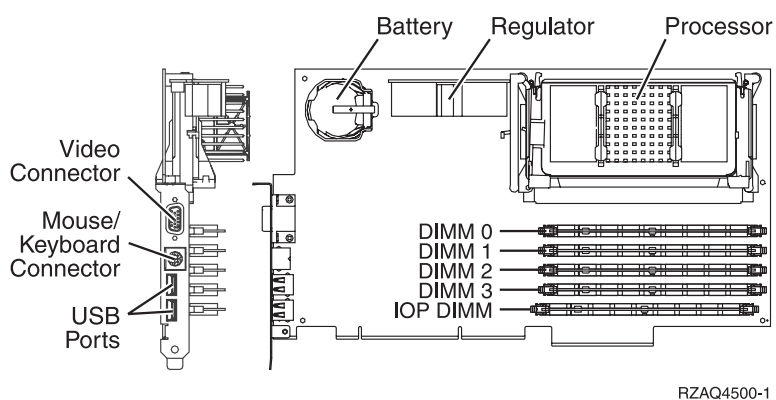
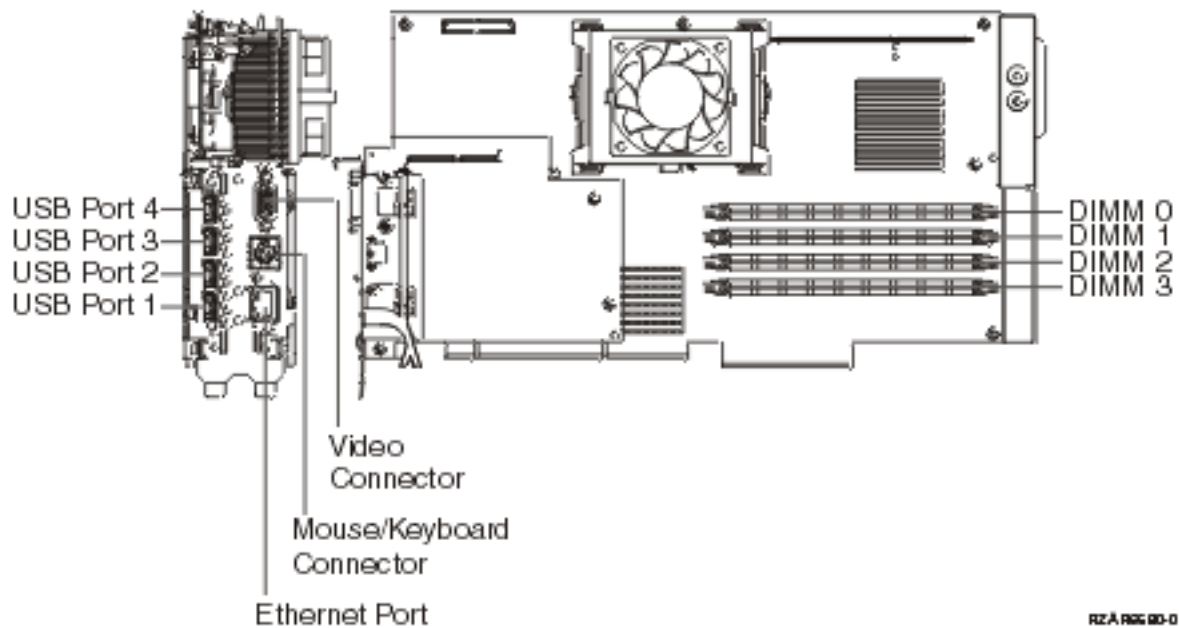
Figure 1. Locations of DIMM 0, DIMM 1, DIMM 2 and DIMM 3 on 2890 Integrated xSeries Server (IXS) card.

In both figures, the **third** DIMM from the top (DIMM 2) of the IXS card is the failing item. To determine the part number, go to symbolic FRU "MEMORY" on page 411.

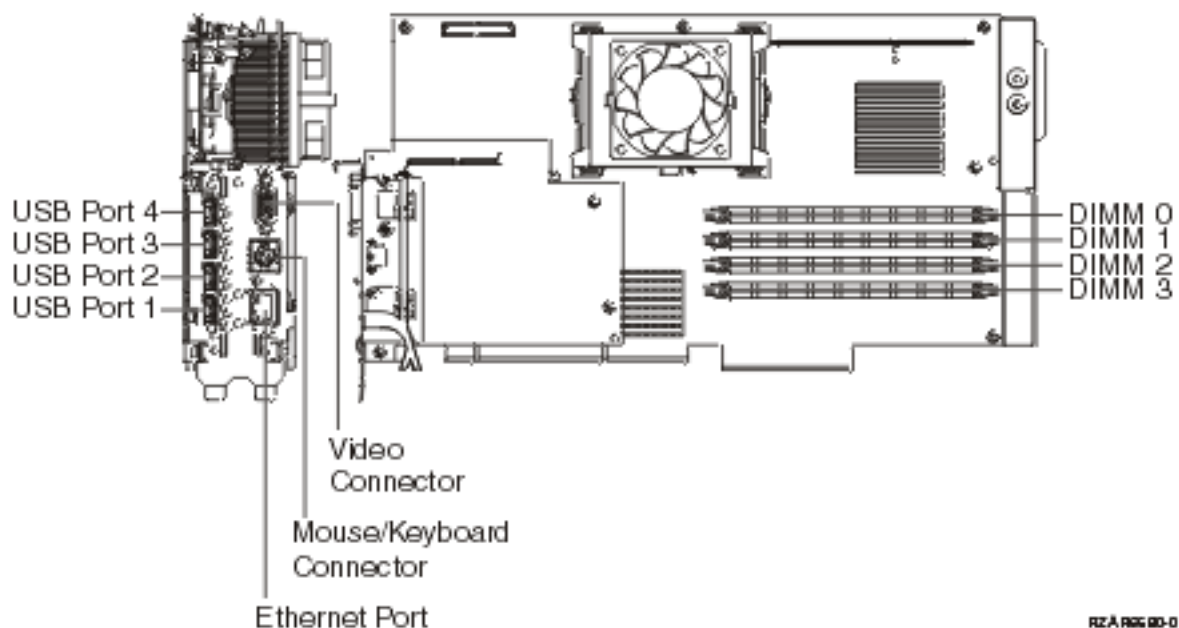
Figure 1. Locations of DIMM 0, DIMM 1, DIMM 2 and DIMM 3 on 2892 Integrated xSeries Server (IXS) card.

The **third** or **fourth** DIMM from the top (DIMM 0 or DIMM 1) of the IXS card is the failing item. To determine the part number, go to symbolic FRU “MEMORY” on page 411.
This ends the procedure.

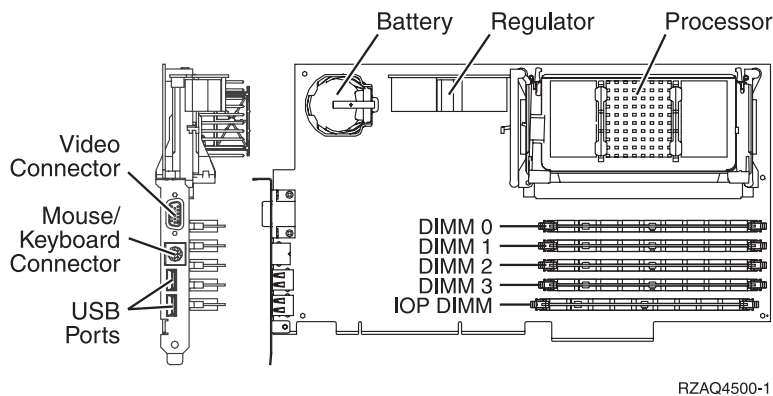
Figure 1. Locations of DIMM 0, DIMM 1, DIMM 2 and DIMM 3 on 2890 Integrated xSeries Server (IXS) card

In both figures, the **fourth** DIMM from the top (DIMM 3) of the IXS card is the failing item. To determine the part number, go to symbolic FRU “MEMORY” on page 411.
This ends the procedure.

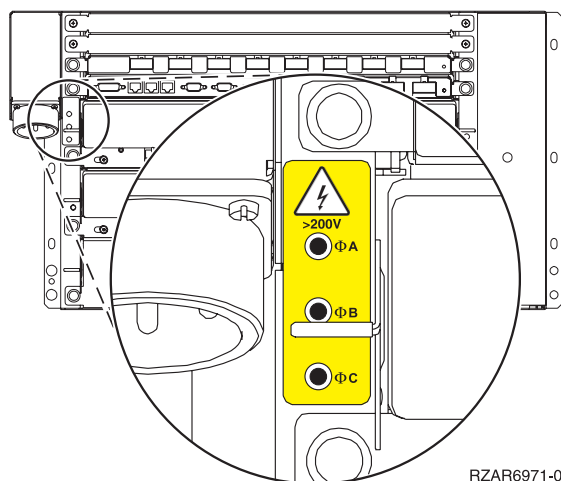
Figure 1. Measuring the ac voltage

- Phase A and phase B
- Phase B and phase C
- Phase C and phase A

Are all the readings greater than 180 V ac?

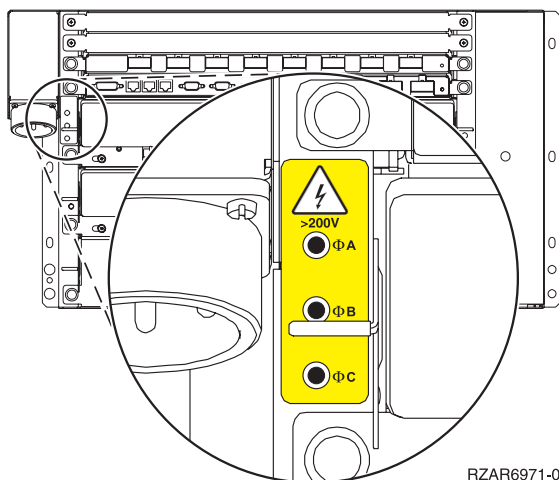
Figure 1. Measuring the ac voltage

- Phase A and phase B
- Phase B and phase C
- Phase C and phase A

Are all the readings greater than 180 V ac?

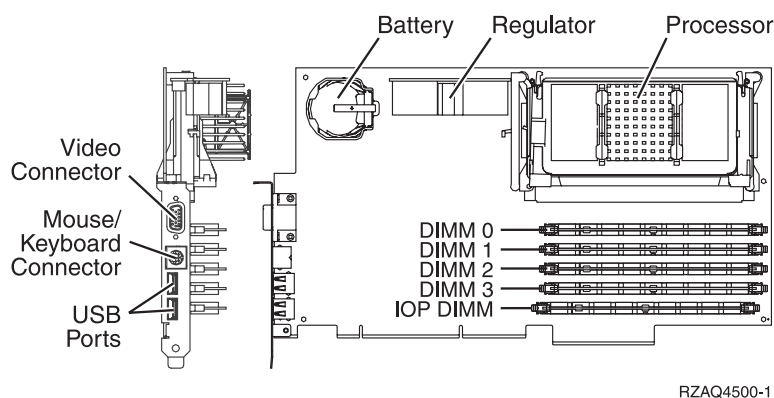
Figure 1. Locations of DIMM 0, DIMM 1, DIMM 2 and DIMM 3 on 2890 Integrated xSeries Server (IXS) card.

Memory for 2890 Integrated xSeries Server (IXS) card: One of the Pentium memory modules (DIMM 0, DIMM 1, DIMM 2, or DIMM 3) may be the failing item.

Feature	Size	Part number
2795/2895	128 MB	29L0955
2796/2896	256 MB	29L0956
2797/2897	1 GB	29L0957

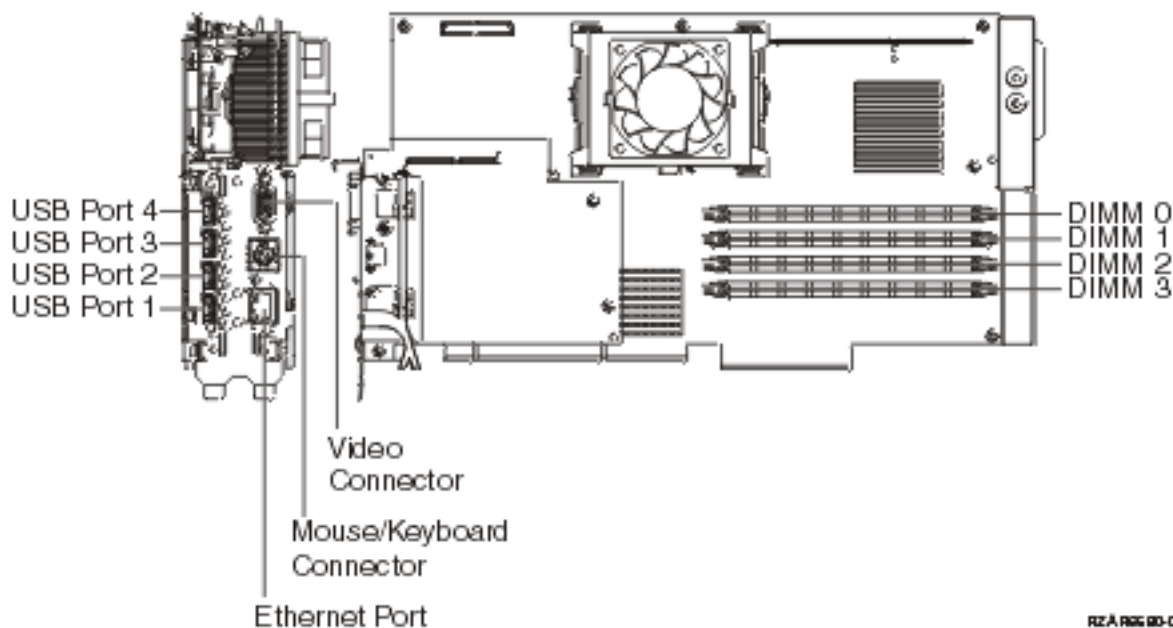
Figure 2. Locations of DIMM 0, DIMM 1, DIMM 2 and DIMM 3 on 2892 Integrated xSeries Server (IXS) card.

Memory for 2892 Integrated xSeries Server (IXS) card: One of the Pentium memory modules (DIMM 0, DIMM 1, DIMM 2, or DIMM 3) may be the failing item.

Feature	Size	Part number
0426/0446	512 MB	00L0000
0427/0447	1 GB	00L0000
